Identification of Buildings Damaged by Natural Hazards Using Very High-Resolution Satellite Images: The Case of Earthquake in L'Aquila, Italy

Luigi Barazzetti and Branka Cuca

Keywords L'Aquila · Earthquake · Quickbird · HR satellite imagery · Remote sensing · Historic centre

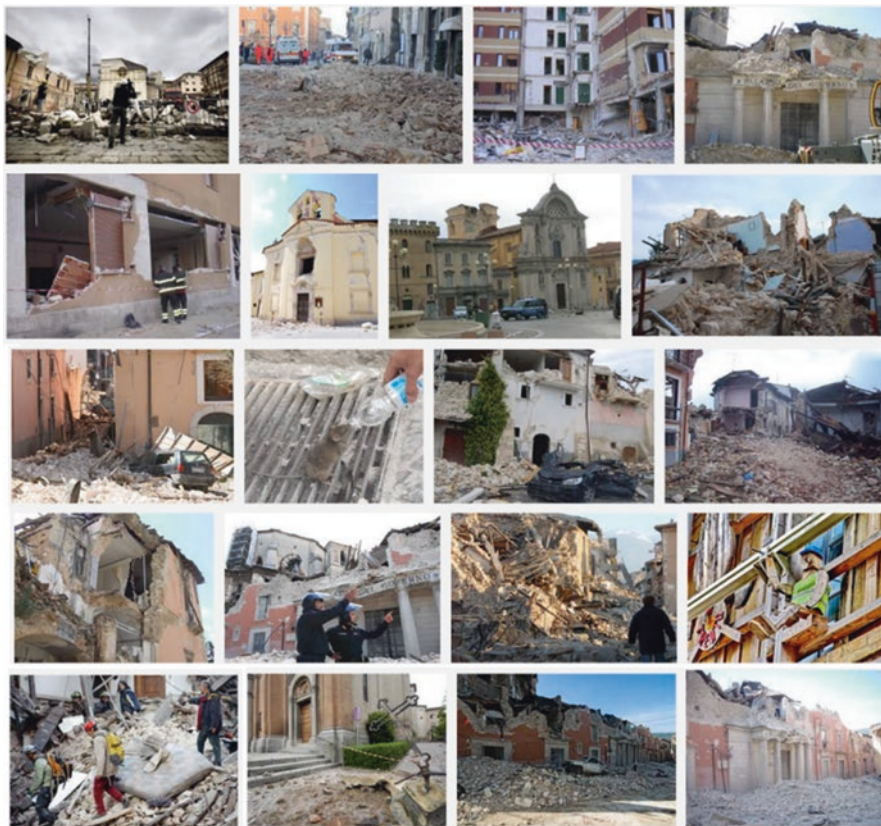
Fig. 3 Several scenes of L'Aquila historic centre, severely damaged during the earthquake occurred in 2009

The earthquake that has struck L'Aquila on 6 April 2009 had an intensity of 5.8–5.9 on the Richter scale, and it has caused 309 human victims in the area. Quite a few buildings, especially in the historic centre that are still surrounded by the mediaeval walls, have undergone serious structural damages (Fig. 3).

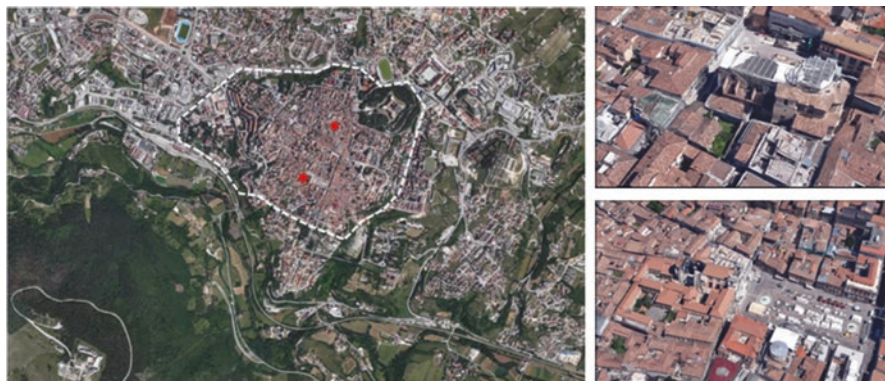
Fig. 4 Perimeter of L'Aquila historic centre shown in white (a); damages of Santa Maria Paganica (b) and of L'Aquila Duomo cathedral (c), background images ©Google

buildings that have undergone damages were churches or other monuments of historic and cultural relevance to the citizens of L'Aquila and the whole region (Fig. 4).

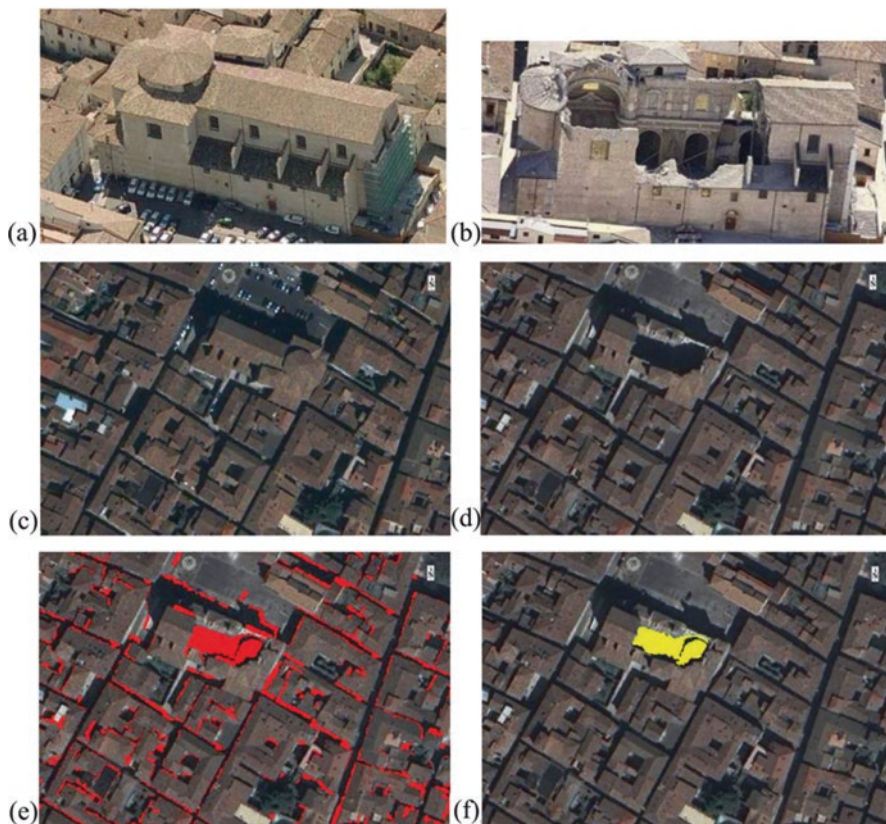
Fig. 8 The area around the church of Santa Maria Paganica: (a, c) Pre- and (b, d) post-event images. The comparison of classification shapefiles provide several errors shown in red colour (e), which are automatically filtered out with the removal of elongated features showing only shadows that indicated the damage, shown in yellow colour (f)

An example of a damaged building examined by this method is the church of Santa Maria Paganica. Figure 8 shows the building and the neighbourhood area before (a, c) and after (b, d) the earthquake. The comparison of classification shapefiles provides several errors (e), which are automatically filtered out with the removal of elongated features, showing only those shadows that with the highest probability indicate the damage caused by the earthquake (f).
