# Clinical evaluation of the performance and safety of a new dentine substitute, Biodentine, in the restoration of posterior teeth — a prospective study

**Objectives** A multicentric randomized, 3-year prospective study was conducted to determine for how long Biodentine, a new biocompatible dentine substitute, can remain as a posterior restoration.

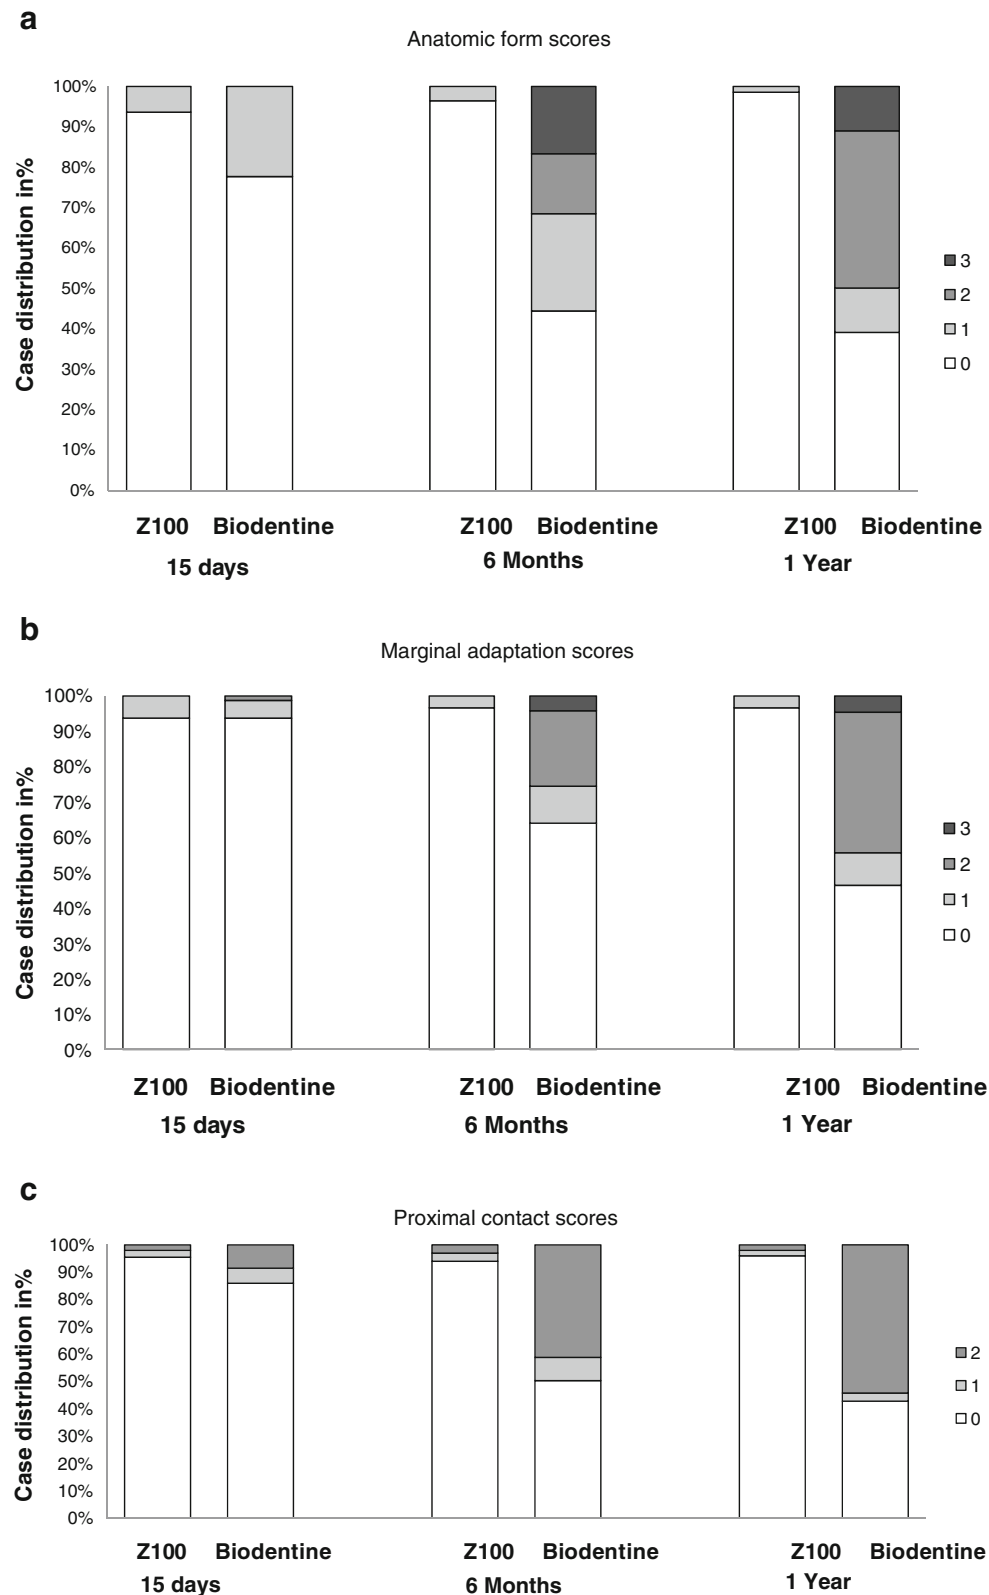
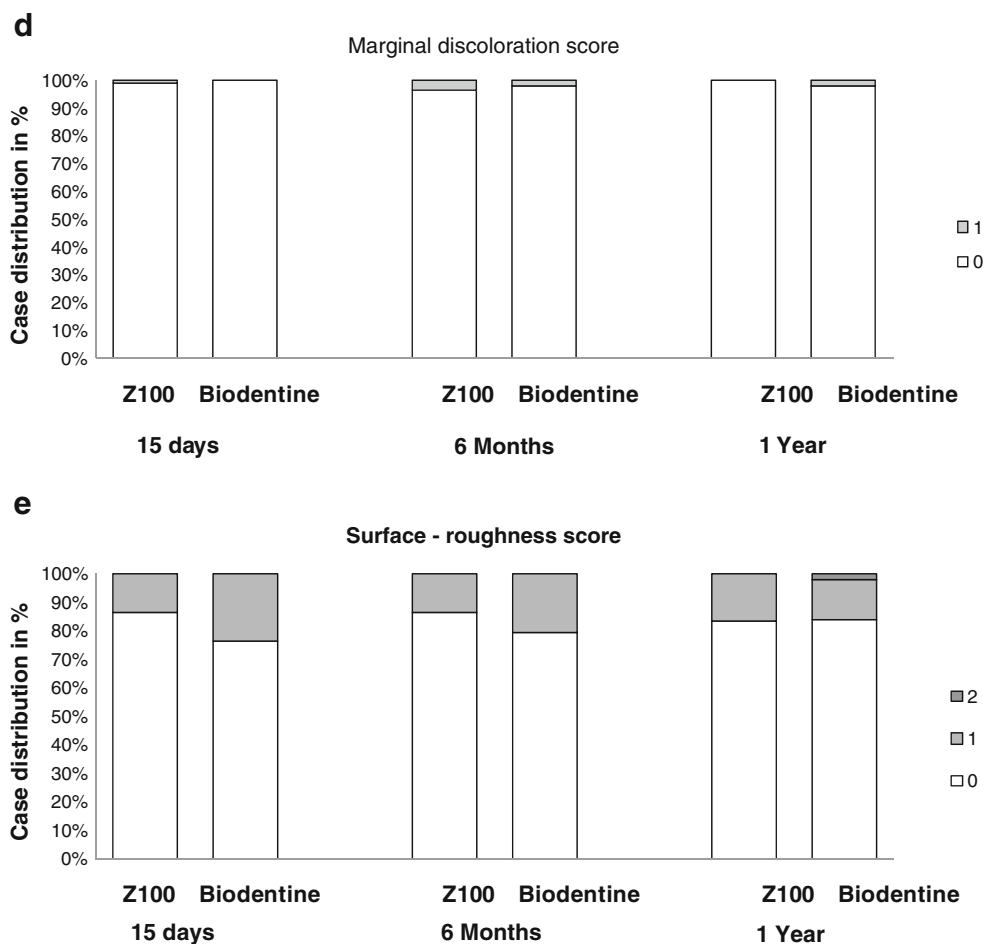
Fig. 1 (continued)

**Fig. 1** Restoration evaluation during the follow-up phase: anatomic form (a), marginal adaptation (b), quality of proximal contact (c), marginal discoloration (d), and surface roughness (e). Shown is the percentage of patients who were attributed the indicated scores at the follow-up visits D15, M6 and M12. The following scores were statistically significantly

different between Biodentine and Z100® restorations: for “anatomic form” at each time point ( $p=0.004$  on D15,  $p<0.001$  at M6 and M12); for “marginal adaptation” and “point of proximal contact” at M6 and M12 ( $p<0.001$ ). The scores for “marginal discoloration” and “surface roughness” were not significantly different

During the follow-up period, product performance was evaluated at each visit. The anatomic form score remained very satisfactory for the majority of patients with Z100® restorations throughout the study. In Biodentine group, the product achieved acceptable scores up to 6 months after the restoration for the anatomic form, the marginal adaptation and the proximal contact. The difference at 6 months and at 1 year between the two groups was statistically significant (Fig. 1a–c).

Marginal discoloration and surface-roughness scores remained very satisfactory in both treatment groups throughout the study (Fig. 1d–e). There was one case of secondary caries reported at M6 in the Biodentine group due to the restoration loss 2 months prior to the visit.

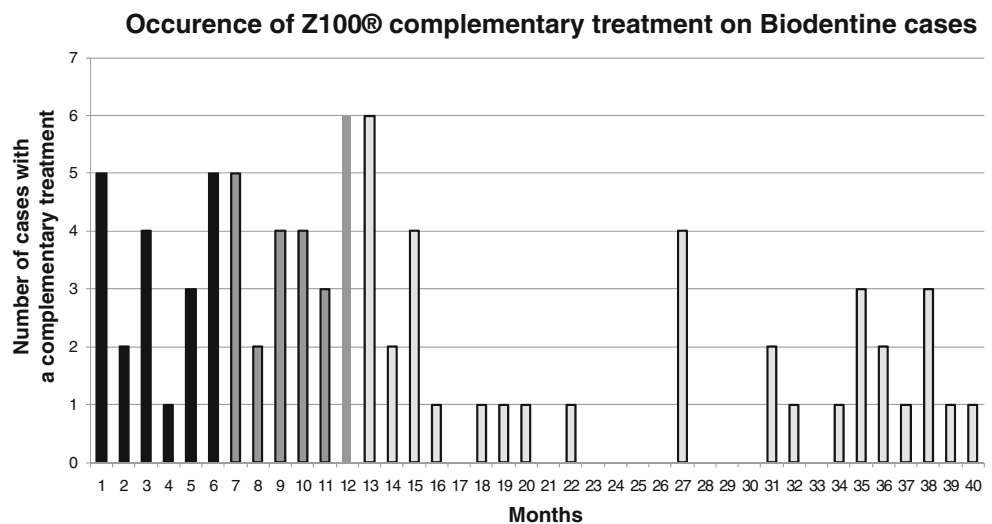
**Fig. 2** Occurrence of Z100® complementary treatment on Biodentine cases. Shown is the number of Biodentine cases recovered by Z100® related to the date (expressed in month) when occurred the complementary treatment of Z100®. Black bars represent 1–6 months, grey bars represent 7–12 months and the light grey bars represent after 12 months

At the time of the analysis, Z100® demonstrated better scores for anatomic form, marginal adaptation and proximal contact than Biodentine at the 6-month visit. This situation was confirmed at 1-year visit. During the follow-up of the first cases, it appeared that Biodentine was abraded and required an additional restoration with Z100®. At the interim evaluation, results showed that 80 cases underwent an additional restoration. Twenty-five percent of cases occurred before the 6-month visit, 30% between 6 months and 1 year and 46% after 1 year (Fig. 2). The reason for placing a composite over the Biodentine was mainly abrasion (on the occlusal surface or on the proximal contact). Details are listed in Table 2. It was decided to systematically add the composite to the Biodentine at the next visit for the other cases. Therefore, the second step
